SERVICE BULLETIN

Service Bulletin Number: SB-001

Subject: Fuel Pump Replacement

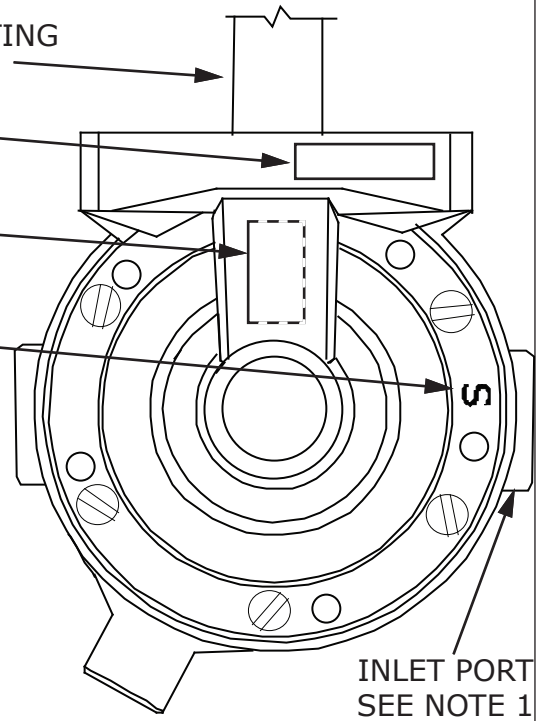
'S' STAMPED ABOVE INLET PORT
INDICATES COMPLIANCE
WITH SB-001

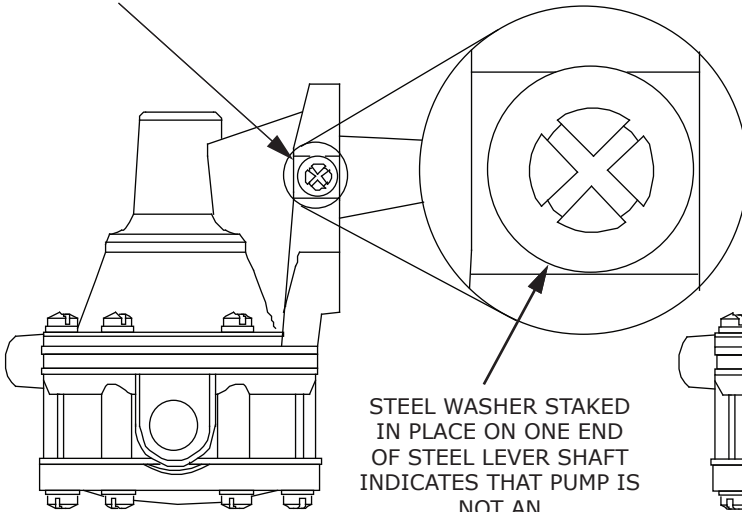
OEM PUMPS

STEEL WASHER STAKED
IN PLACE ON ONE END
OF STEEL LEVER SHAFT
INDICATES THAT PUMP IS
NOT AN
AERO ACCESSORIES, INC
OVERHAULED PUMP

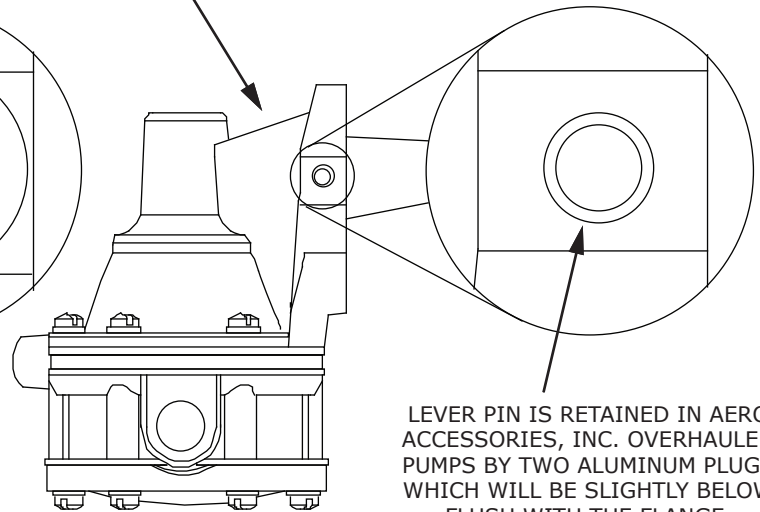
**AERO ACCESSORIES
PUMPS**

LEVER PIN IS RETAINED IN AERO
ACCESSORIES, INC. OVERHAULED
PUMPS BY TWO ALUMINUM PLUGS
WHICH WILL BE SLIGHTLY BELOW
FLUSH WITH THE FLANGE
SURFACES ON BOTH SIDES
