SERVICE BULLETIN

Service Bulletin Number: SB-002

Subject: HIGH PRESSURE Fuel Pump Replacement

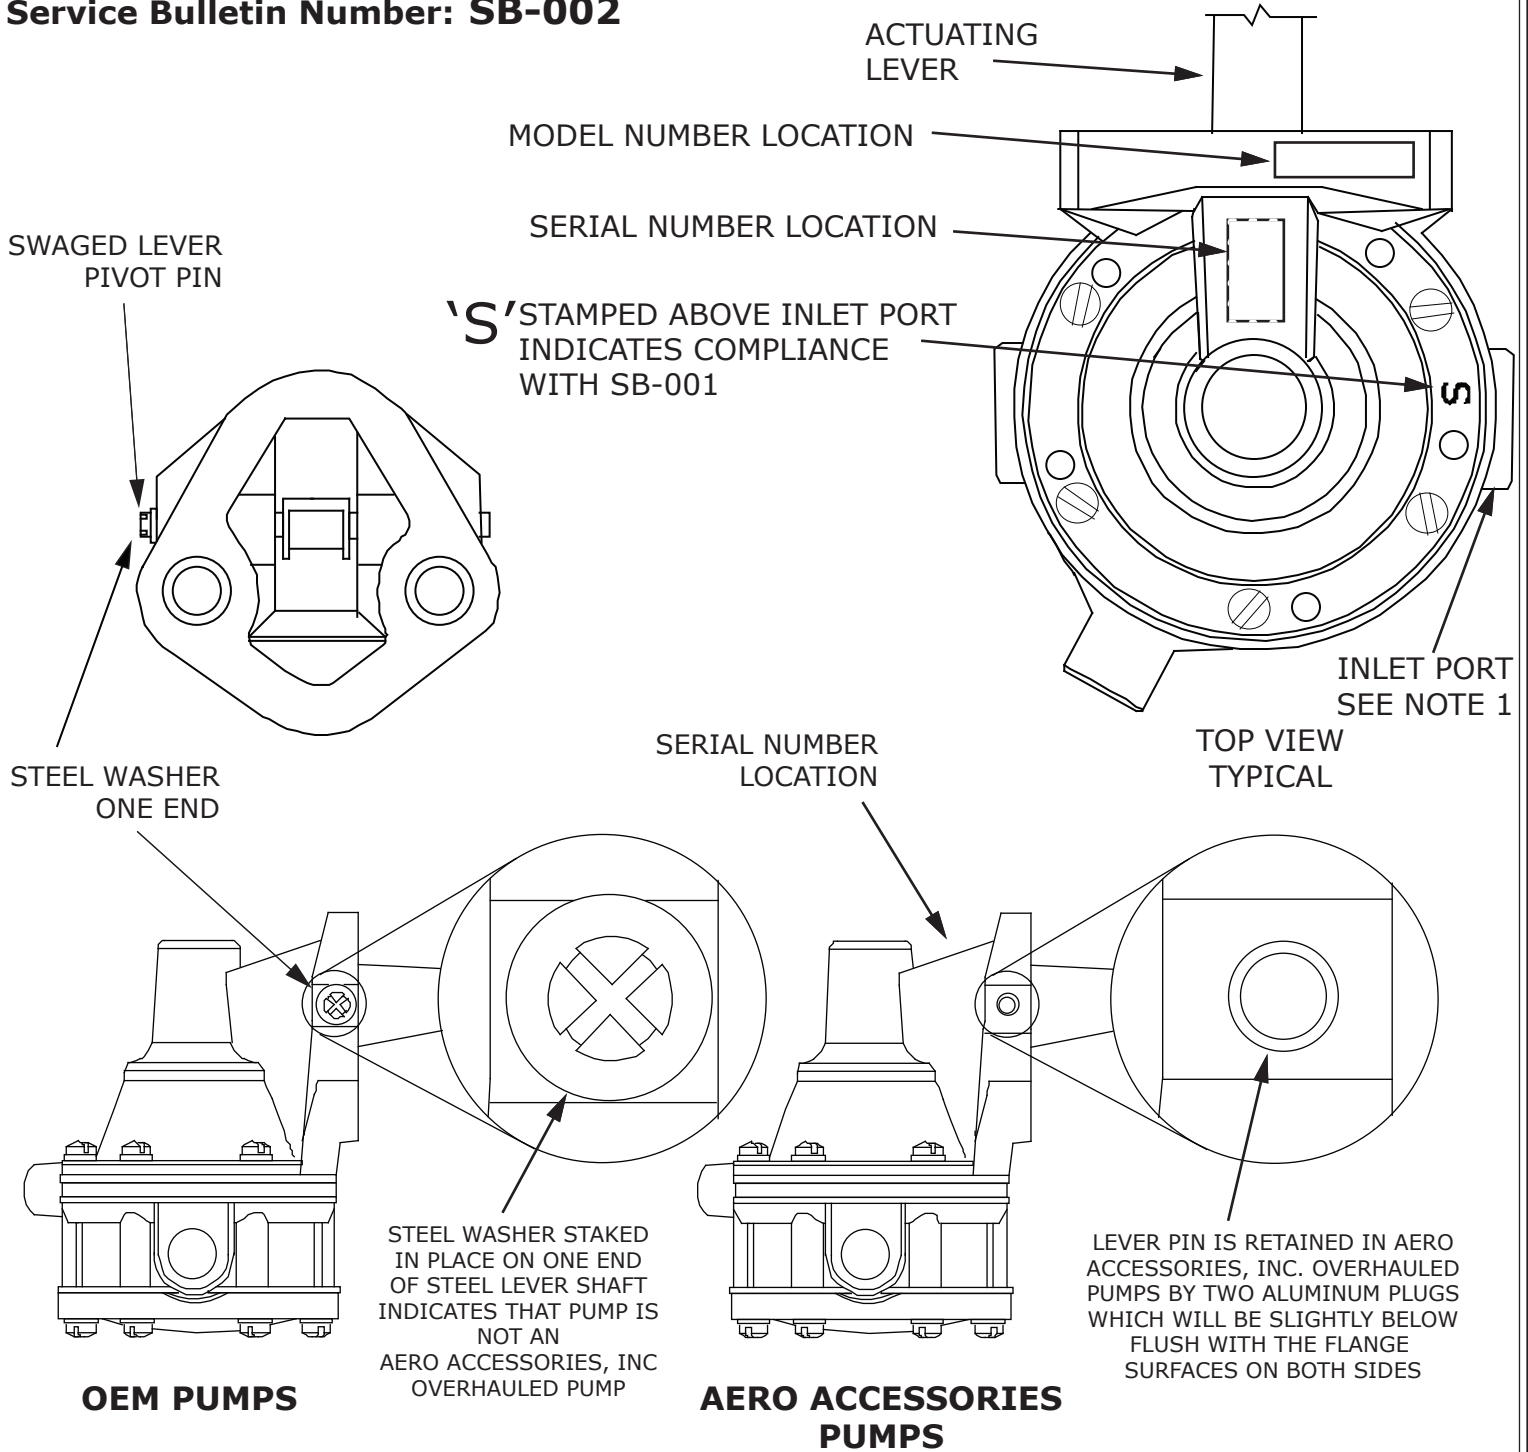
Affected units listed above which are in compliance with Service Bulletin SB-002 will be identified by the characters 'S2' stamped as indicated on Page 2 of this Service Bulletin.

1. Port locations vary on some model pumps.
2. Some OEM units may use the Aluminum Pin Retaining System also, therefore, before removing a pump, verify that the Serial Number is on the affected list. Aero Accessories, Inc. has never used the steel washer system.
