SERVICE LETTER

Service Letter Number: SL-004-1

Subject: REAR Wear Indicator Instructions Overhauled Pumps

Applicability: Overhauled Tempest AA215CC/AA216CW or Airborne 215CC/216CW Dry Air Pumps

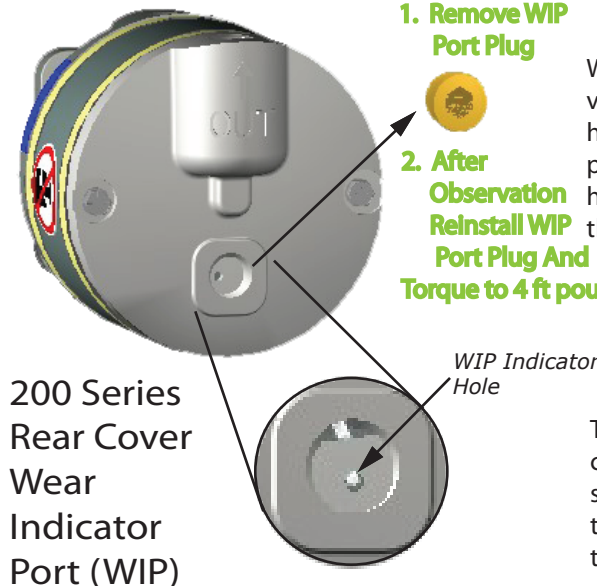
At 600 hours pump service life perform a visual observation of the wear port indicator. If the top of the vane has not entered the indicator hole, the next observation should be performed at 1000 hours of pump service life.

At 600 hours pump service life the visual observation reveals the backside of the vane has entered the indicator hole, the next observation should be performed at 800 hours of pump service life.

When observations reveal the end of the vane to be in the middle of the indicator hole, future observations should be performed at every one hundred (100) hours of service until the vane reaches the bottom 1/8 of the indicator hole.

1. Remove WIP Port Plug

2. After Observation Reinstall WIP Port Plug And Torque to 4 ft pounds

To help prevent in-flight failure due to a critically short vane binding in a rotor slot, replace the pump when the end of the vane is observed in the lower 1/8 of the indicator hole.
