AERO ACCESSORIES, INC.  
**SERVICE BULLETIN**

**SERVICE BULLETIN: SB-009**  
**SUBJECT: Possible Loose Contact Button.**  
**APPLICABILITY: Contact Assembly A-13081.**

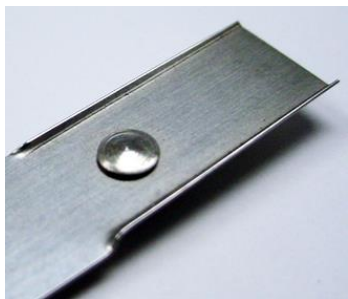
- c. Measure the diameter of the upset shop head of the rivet. It must be no less than .130 inch in diameter.

$\phi$ .150  
.130  
SPRING CONTACT  
BUTTON SHOP HEAD

- d. If there is any evidence of looseness of the contact button, and/or a gap exists under the contact button, and/or the diameter of the upset head of the contact button is less than .130 inch, remove and replace the contact assembly with a contact assembly having a date code other than those affected by this bulletin.
