**AERO ACCESSORIES, INC.
SERVICE BULLETIN**

**SERVICE BULLETIN: SB-010
SUBJECT: DIAPHRAGM FUEL PUMP LEVER DAMAGE
APPLICABILITY: DIAPHRAGM FUEL PUMPS**

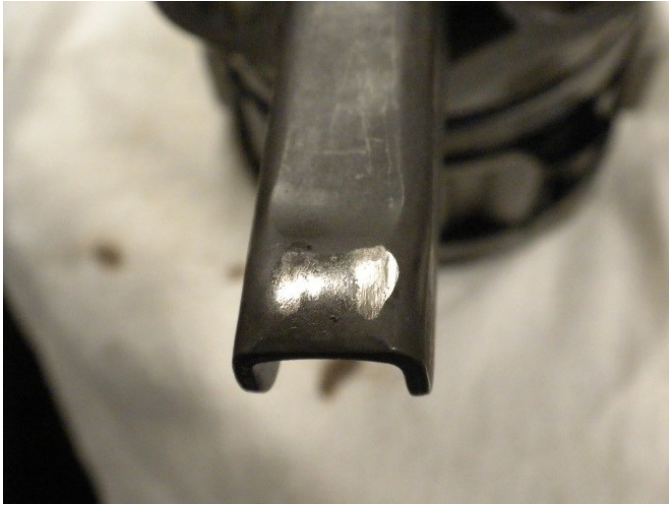
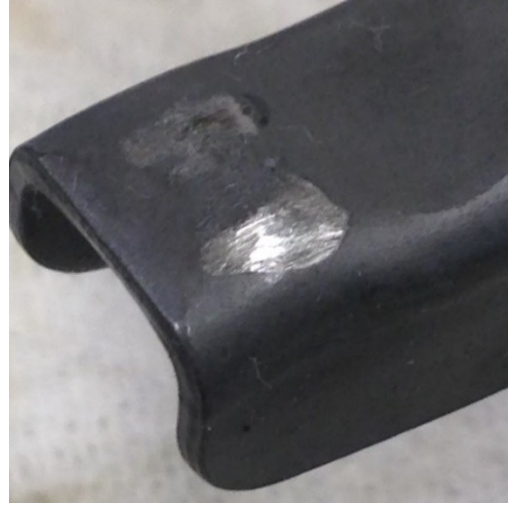
- a. Photo 1 shows an example of a damaged pump lever. Photo 2 shows a pump lever exhibiting normal wear. Note that normal wear appears as a localized shiny spot near the center of the pump lever’s pushrod pad and does not exhibit scratches, displacement of metal, or worn away metal. Photo 3 shows the end of a damaged pushrod. Note the worn, chipped, scratched, rounded end of the pushrod. Note further that in this example, scalloping is evident around the pushrod’s perimeter. Lesser damaged rods may not exhibit all these damage signatures. Photo 4 shows the end of a pushrod exhibiting normal wear. Note that a normally worn and serviceable pushrod contacts the lever in the approximate center one third (approximately) of the pushrod’s end diameter, as highlighted in photo 5, and that the outer portions of the pushrod’s end surface show no sign of contacting the pump’s lever. In this normally worn example, there is no deformation, scalloping, chipping etc. of the pushrod’s end and the majority of the rod’s original machining marks remain intact.

**Photo – 1
Damaged Pump Lever**

- b. If any damage is observed – DO NOT INSTALL a fuel pump on the engine until a thorough investigation of the fuel pump drive train, including the pushrod, the hole in the accessory case that guides the pushrod, and the eccentric that drives the pushrod, is carried out in accordance with the engine manufacturer’s instructions and the engine is determined to be in serviceable condition.

- c. If damage to the lever of a pump previously installed on an engine is discovered, **DO NOT RE-INSTALL** the pump on the engine. Contact Aero Accessories, Inc. regarding the pump and its possible repair.

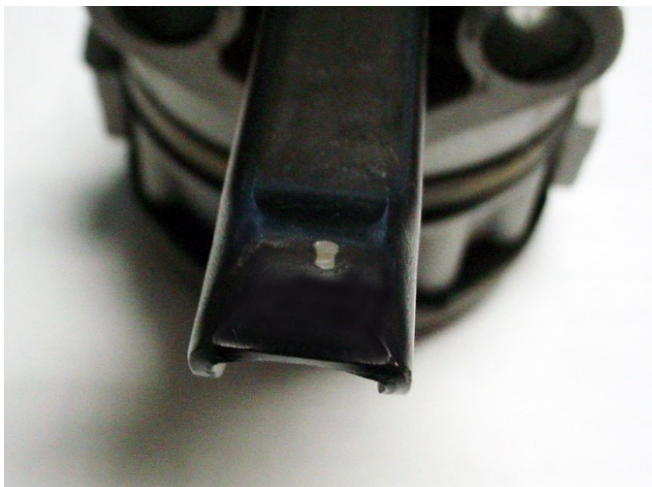
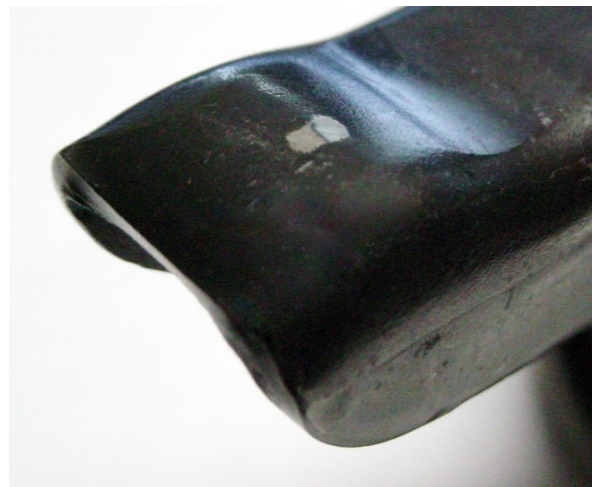
**Photo – 2
Pump Lever Exhibiting Normal Wear**

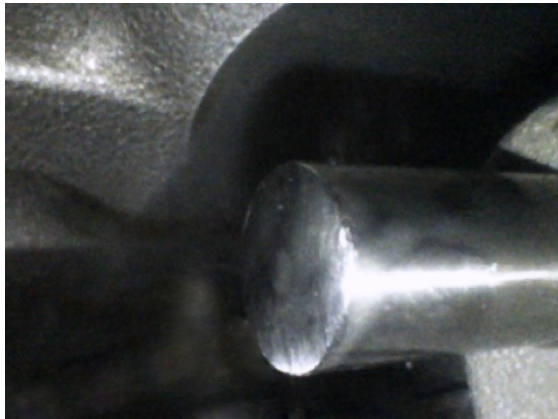
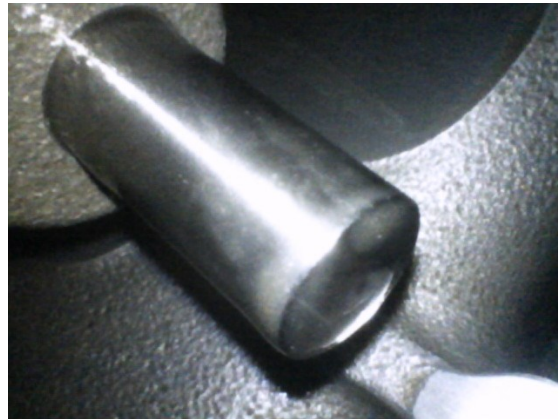
Photo – 3
Damaged Push Rod

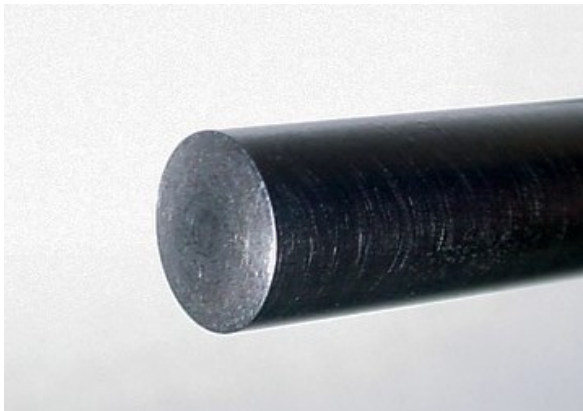
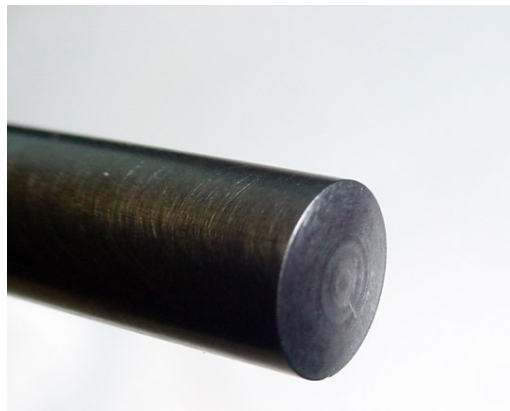
Photo – 4
Push Rod Exhibiting Normal Wear

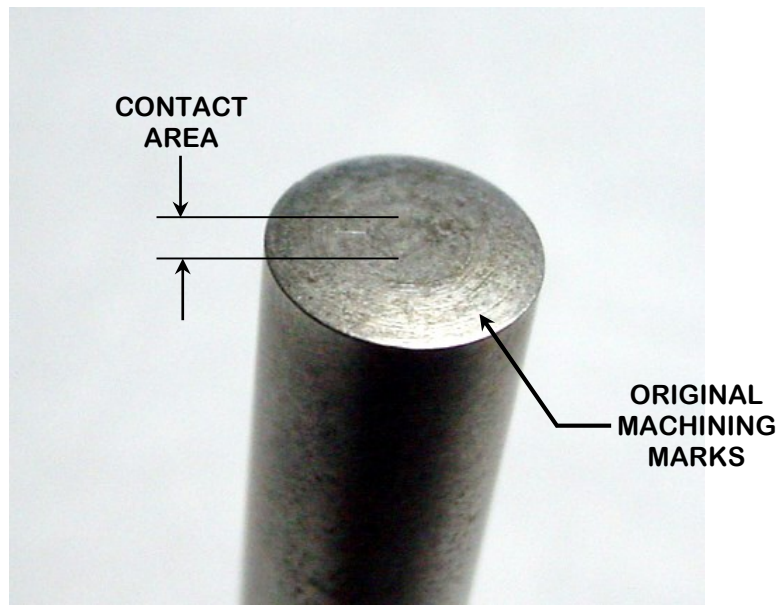
Photo – 5
Push Rod Exhibiting Normal Wear

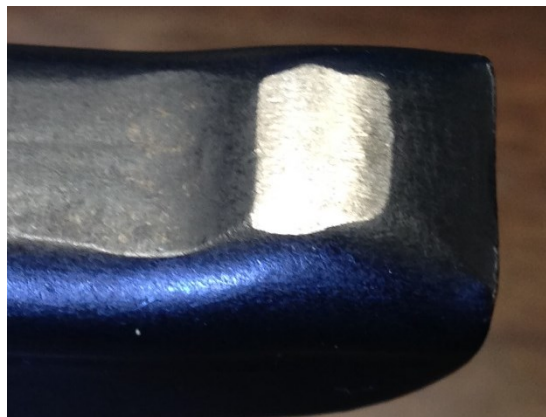
Photo – 6
Pump Lever from 62B Series Pump
Exhibiting Abnormal Wear
