SERVICE BULLETIN

Service Bulletin Number: SB-001

Subject: Fuel Pump Replacement.

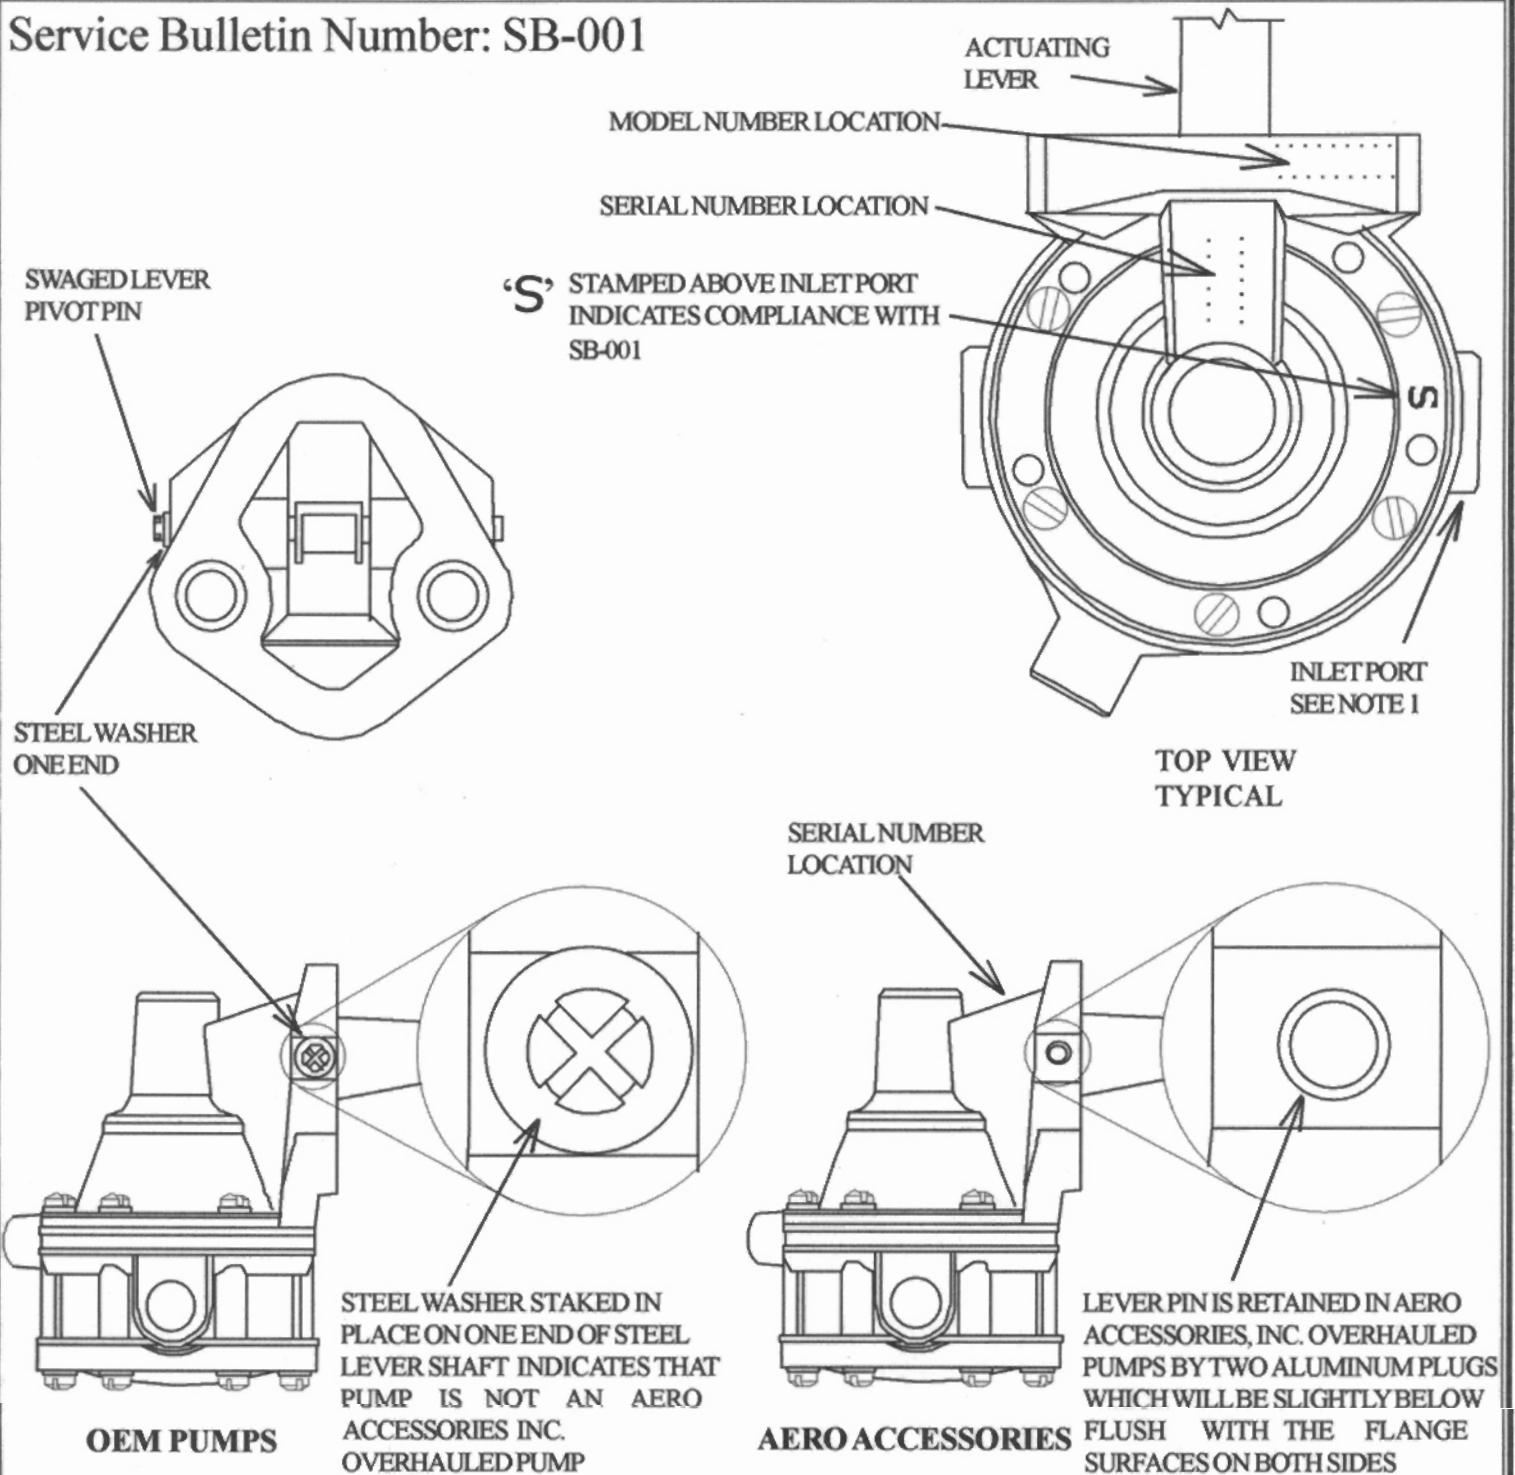
Aero Accessories has determined that the installed outside diameter of the diaphragm stem seal in a group of AC / Lycoming diaphragm fuel pumps overhauled by Aero Accessories, Inc. during the period November, 1991 thru August 20, 1992 may vary from unit to unit. This exposes the unsupported edge of the seal to the fuel flow through the pump. If a particle of the seal were to break off, it could lodge in the fuel system and result in partial or complete power loss.

1. Port locations vary on some model pumps.
2. Some OEM units may use the Aluminum Pin Retaining System also, therefore, before removing a pump, verify that the Serial Number is on the affected list. Aero Accessories, Inc. has never used the steel washer system.

Pumps serviced by Aero Accessories on or after August 21, 1992 are in compliance with this Service Bulletin. Pumps returned and inspected will be impression stamped with the letter 'S' on the upper casting flange above the inlet port as referenced on Page 2 of this Service Bulletin.
