SERVICE BULLETIN

Service Bulletin Number: SB-002

Subject: HIGH PRESSURE Fuel Pump Replacement.

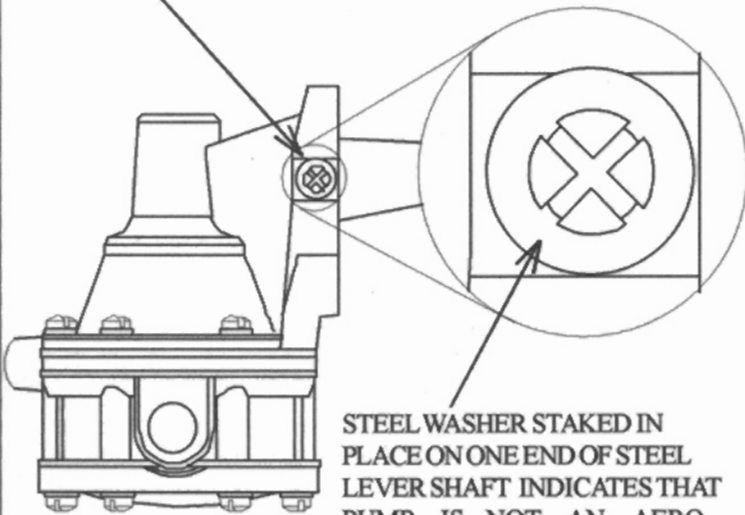
OEM PUMPS

STEEL WASHER ONE END

STEEL WASHER STAKED IN PLACE ON ONE END OF STEEL LEVER SHAFT INDICATES THAT PUMP IS NOT AN AERO ACCESSORIES INC. OVERHAULED PUMP

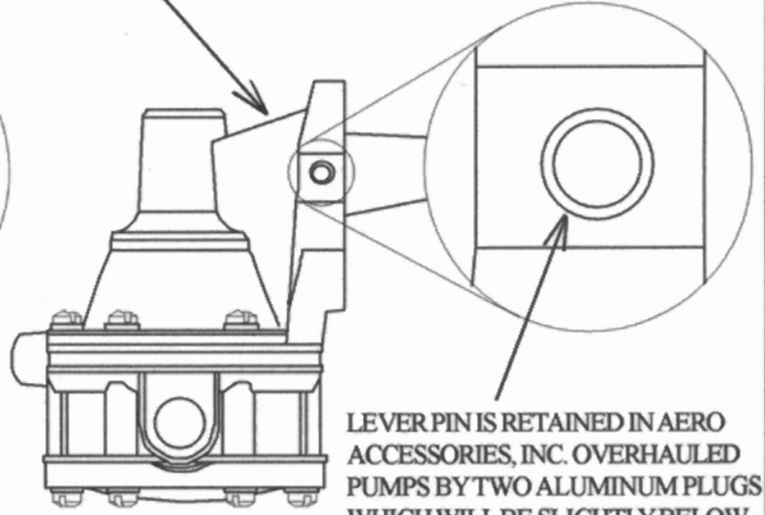
AERO ACCESSORIES

LEVER PIN IS RETAINED IN AERO ACCESSORIES, INC. OVERHAULED PUMPS BY TWO ALUMINUM PLUGS WHICH WILL BE SLIGHTLY BELOW FLUSH WITH THE FLANGE SURFACES ON BOTH SIDES

1. Port locations vary on some model pumps.
2. Some OEM units may use the Aluminum Pin Retaining System also, therefore, before removing a pump, verify that the Serial Number is on the affected list. Aero Accessories, Inc. has never used the steel washer system.
