AERO ACCESSORIES, INC.
SERVICE BULLETIN

SERVICE BULLETIN: SB-009
SUBJECT: Possible Loose Contact Button.
APPLICABILITY: Contact Assembly A-13081.

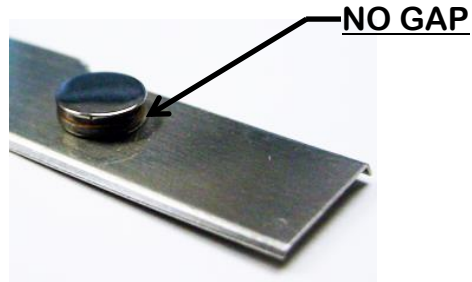
CONTACT BASE TOUCHING
SPRING AROUND ENTIRE
CIRCUMFERENCE
NO GAPS

- b. The contact button must be tightly riveted to spring element and exhibit no evidence of looseness. There must be no gap between the underside of the contact button and the spring or base.

- d. If there is any evidence of looseness of the contact button, and/or a gap exists under the contact button, and/or the diameter of the upset head of the contact button is less than .130 inch, remove and replace the contact assembly with a contact assembly having a date code other than those affected by this bulletin.

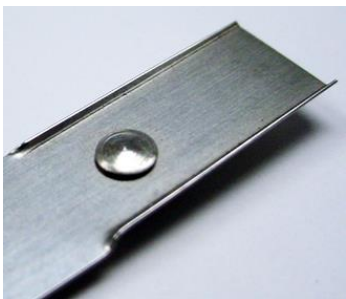
- c. Measure the diameter of the upset shop head of the rivet. It must be no less than .130 inch in diameter.

ϕ .150
..130
SPRING CONTACT
BUTTON SHOP HEAD
