**AERO ACCESSORIES, LLC
SERVICE BULLETIN**

SERVICE BULLETIN: SB-011

SUBJECT: Possible Damaged O-Ring

APPLICABILITY: Tempest® Electronic Fluid Pump

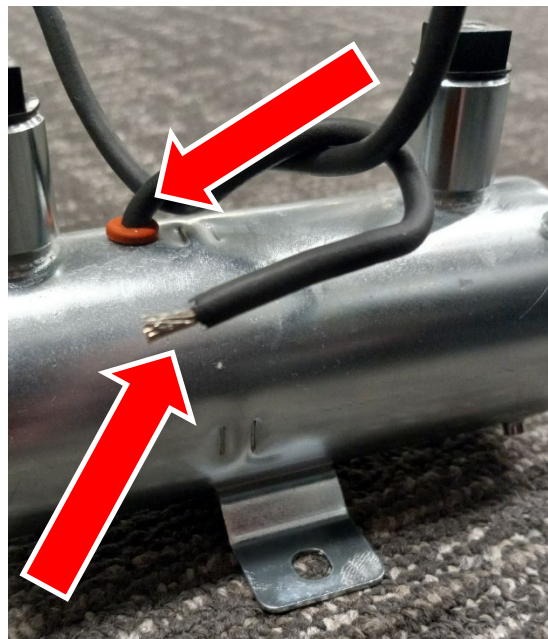
Figure 1

Background: There has been a report from the field of a fluid leak in a Tempest® Electronic Fluid Pump. The area of the leakage was observed at the grommet and, or the end of the lead wire. See Figure 1.

Compliance: When installing a Tempest® Electronic Fluid Pump, operate the pump with fluid. Verify that no fluid is leaking from the fitment points, the end of the lead wire, or around the grommet, See Figure 1. If there is evidence of a leak, do not use the pump, return the pump for an exchange.

Previously Installed Pumps: Tempest® Electronic Pumps that have previously been installed need to be reinspected for leaks within 10 flight hours or 45 days from the effective date of this service bulletin, whichever occurs first. The inspection must be done while the pump is operating and the fluid is present.

If there is evidence of a leak, do not use the pump, return the pump for an exchange.
