**AERO ACCESSORIES, LLC
SERVICE BULLETIN**

SERVICE BULLETIN: SB-011

SUBJECT: Possible Damaged O-Ring

APPLICABILITY: Tempest® Electronic Fluid Pump

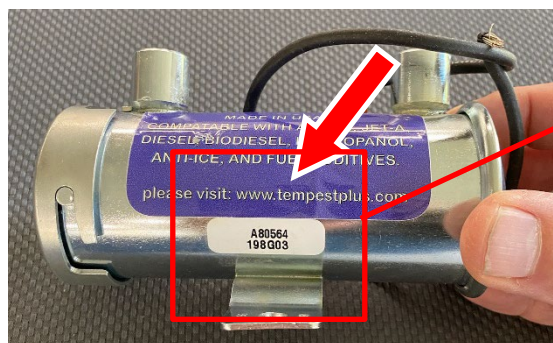
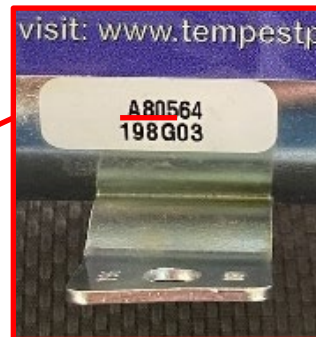
SERIAL NUMBER
198G03
LOT CODE

Lot Number is located on separate label above mounting flange.
