**RE: Service Bulletin — Inspection and Replacement of Tempest Spark Plugs, Specific Lots**

**SERVICE BULLETIN SB-012****August 7<sup>th</sup>, 2026**

This Service Bulletin describes a potential cracking problem in specific lot numbers of Tempest® Spark Plugs manufactured between May 5, 2026 and July 29, 2026. It recommends immediate inspection of the affected spark plugs prior to your next flight and replacement of any cracked spark plugs. No action is required for Tempest® Spark Plugs purchased prior to May 5, 2026.

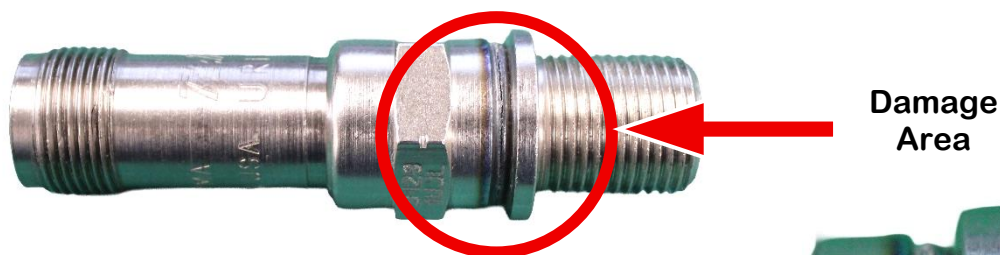
**Figure 1**

There have been limited reports of spark plugs exhibiting cracks. Failure to detect and replace a cracked spark plug could potentially result in damage to the airplane engine and possible loss of power.

There have been field reports of cracks in Tempest® spark plugs. The area of damage is shown in Figures 1 & 2.

3. If an affected spark plug is found to be installed, remove the affected spark plug(s) from the engine and visually inspect for cracks as shown in Figures 1 and 2. Similarly, inspect any affected spark plugs in inventory.

5. If cracks are found, replace the spark plug(s). If replacing with new Tempest® spark plug(s), verify the new spark plugs carry compliance stamp SB012 as shown in Figure 4 or are outside the part number and lot numbers listed in Table 1 above.

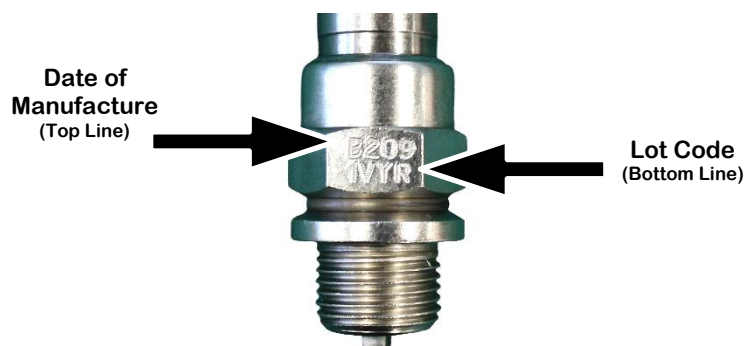
Visually inspect the spark plug for lot code per Figure 3. The lot code is stamped on the hex of the spark plug body as shown. Compare the stamped lot code to the affected part numbers and lot numbers listed in Table 1. Physical inspection of spark plugs is required. Remove from engine as required to confirm part number a lot code.

1. Determine if a spark plug is included in the affected lots (Table 1) using a visual inspection as shown in Figure 3 or by referencing an FAA 8130 from the latest spark plug installation as shown in Figure 5.
